## ***Method of Shower Repair*** ***Waterproofing Conforms to AS 3740.***

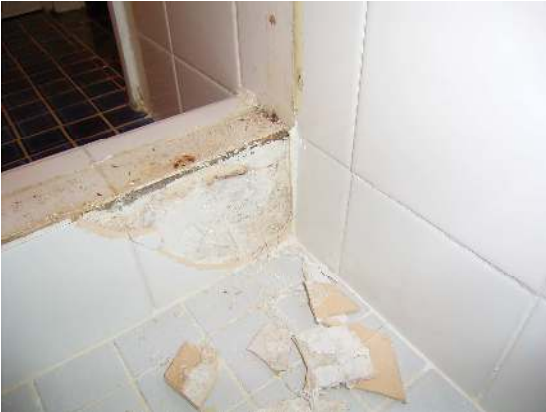
1. Remove existing wall tiles

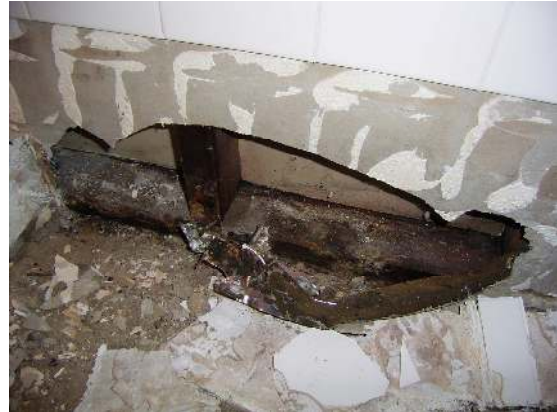
3. Repair or replace broken wall sheeting if required

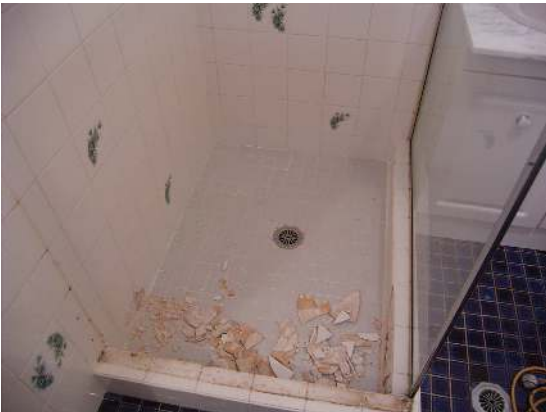
2. Removal of wall tiles and remove floor tiles

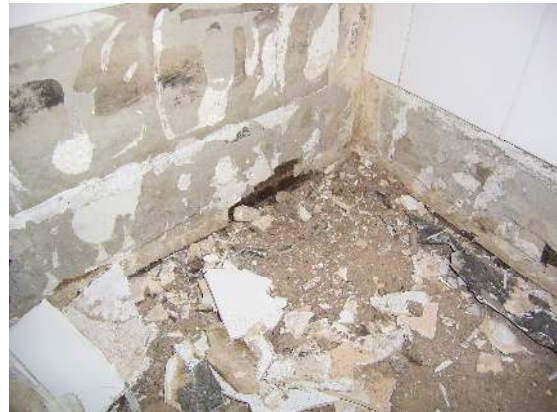
4. Repair or replace broken wall sheeting if required

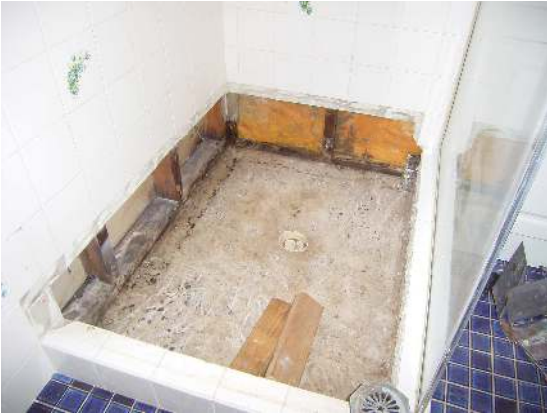
5. Remove broken wall sheeting and replace with new.

NOTE: normally only one row of wall tiles is removed, however in this case due to broken wall sheeting more than one row had to be removed.

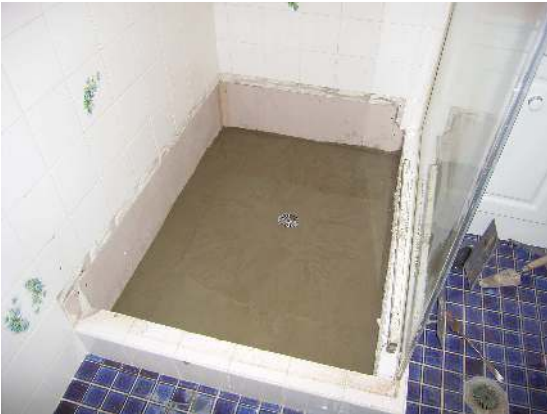
6. New wall sheeting installed, new mortar bed also installed

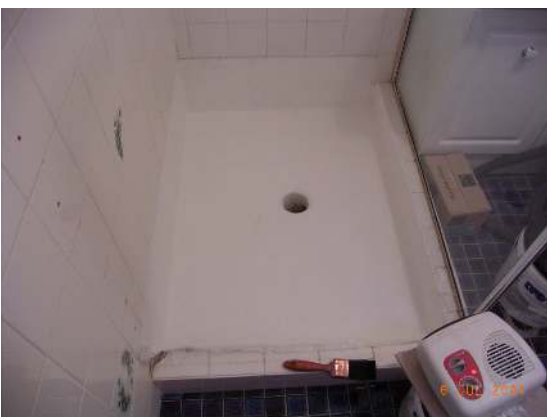
7. Waterproofing to AS 3740 installed.

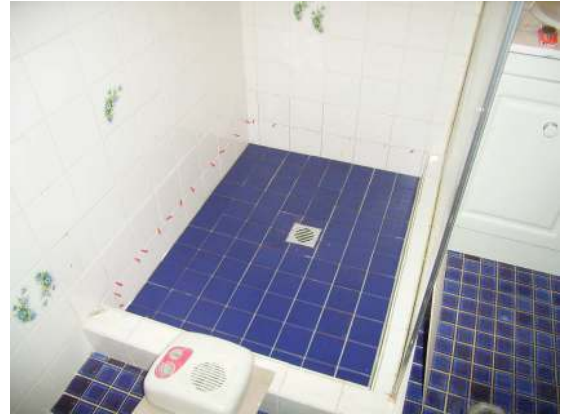
8. New wall tiles and floor tiles installed prior to grouting.

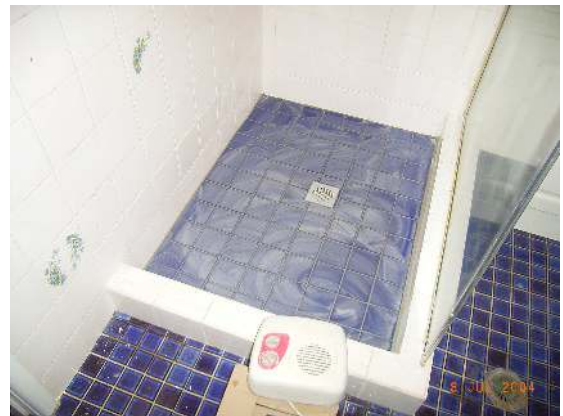
9. Floor and wall tiles grouted prior to cleaning.

NOTE: it is not always possible to obtain tiles that are a perfect match to the existing.
